GIS Evaluation of the Impacts on the Built and the ‘Natural’ Environment of the 11 March 2011 Tsunami in Rikuzentakata, Iwate Prefecture, Japan

C. Gomez^{1,2*}, P. Wassmer^{3,4}, C. L. Kain¹, M. De Villiers¹, K. Campbell¹, S. Ward¹, A. Moghaddam¹

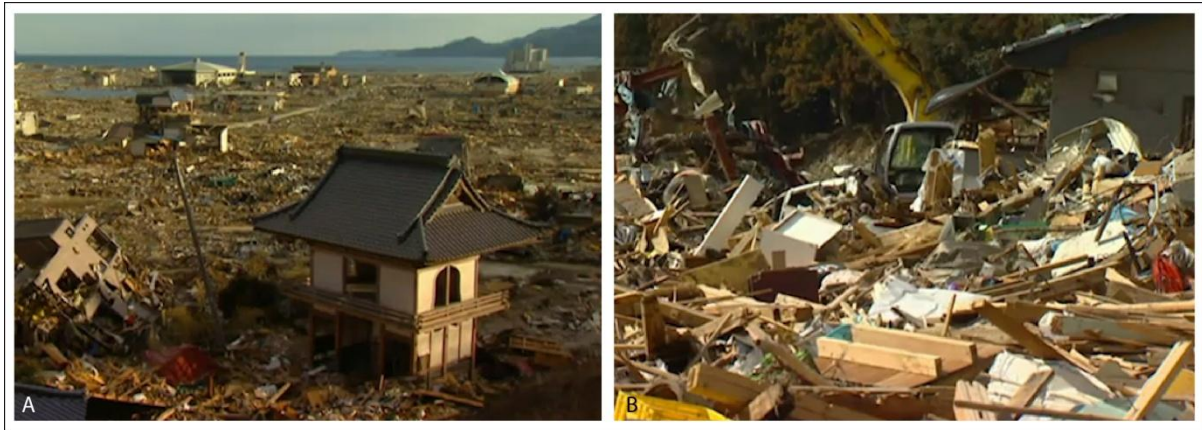
(2011) respectively. As at 1st May 2011, 24,000 people were reported dead or missing and 350,000 were living in refuge areas. One of the areas with the worst damage is the municipality of Rikuzentakata, which is located in Iwate Prefecture on the east coast of the Tohoku region (Fig. 1). It is situated at the back of a 3 km wide bay that opens to the Pacific Ocean, and on the estuary of the Kesen River. The municipality extends over 232.29 km² with 23,302 inhabitants in 2010. The population was mainly making a living from oyster farming (40 million yen revenue in 2010) and from the location as a scenic attraction; with the Takata Matsubara Park declared a ‘Place of Scenic Beauty’ by the Japanese Ministry of Environment from the year Showa 2 (y.1927). The position of Rikuzentakata and the distribution on lowland of the principal infrastructure such as the City Hall and the schools, which are used as refuge location during natural disasters, increased the tsunami vulnerability. As per the mass-media broadcast, most of the city has been wiped from the map (Fig. 2).

Fig. 2 View of the bay in front of Rikuzentakata (A) and zoom of the rubble in the destroyed municipality (source: images extracted and adapted from Al Jazeera, 2011)

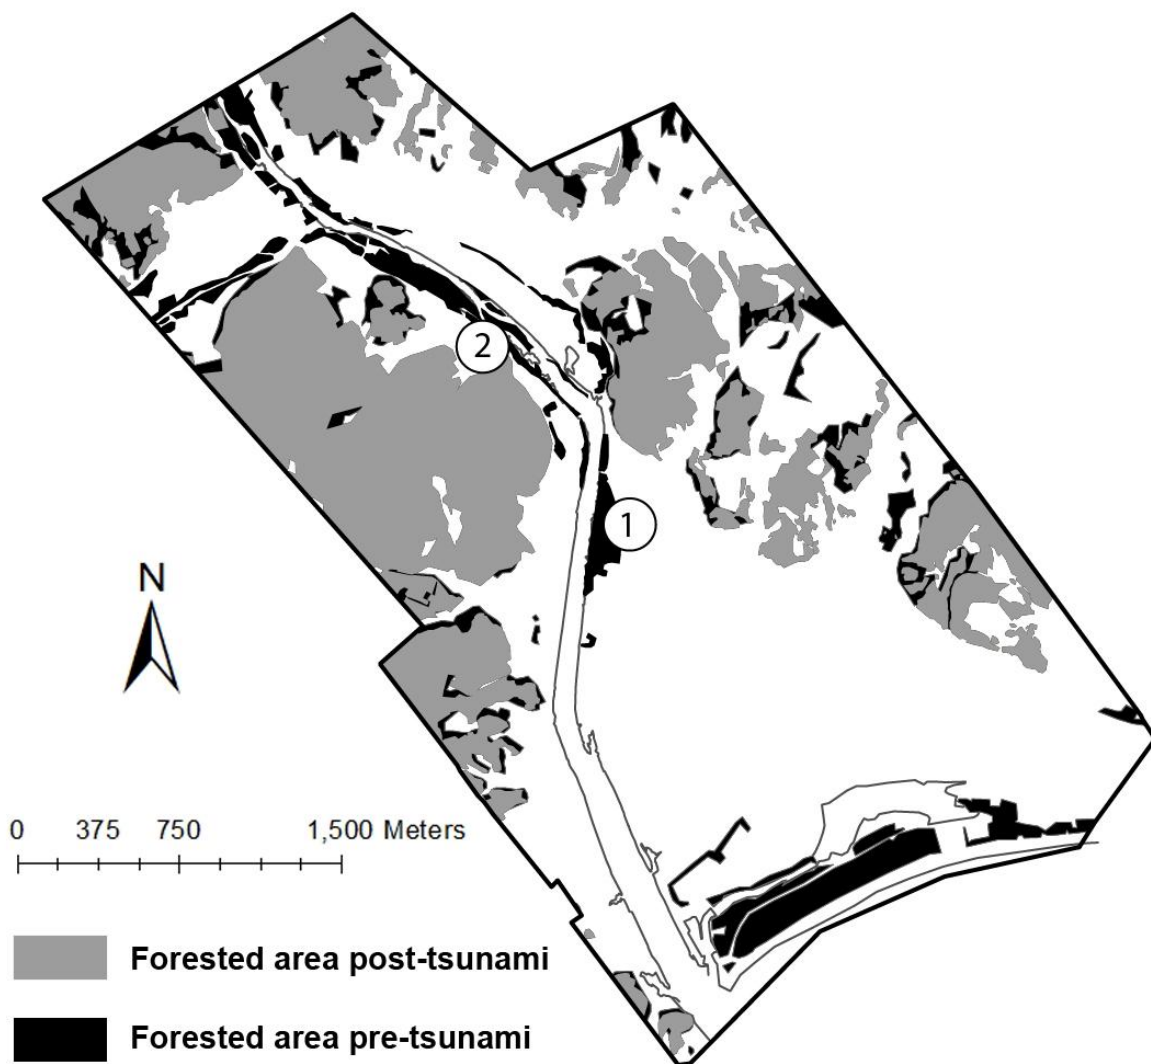
Along the 4.8 km of the Kesen River, all riparian trees have been uprooted and transported or flattened down by the tsunami. The loss of riparian forested area has been 0.29 km² along the Kesen river and 0.34 km² along the Kesen River and its tributary. The tsunami has destroyed both large and small clusters of forested land. The largest of these is 51,000 m², located between 3 km and 3.8 km from the mouth of the Kesen River. Destruction extends laterally

195 m from the closest bank and 250 m to the active channel central line. The largest area of flattened trees (1 on Fig. 7) measures 42,000 m². It is located on a left pointbar, along the Kesen River, only 2.5 km from the river mouth. The second area, where trees have been flattened is located on a right bar (2 on Fig. 7). It is 5,500 m² and it is located 3.6 km from the river mouth.

Because of the physical destruction of the lagoon's barrier, forested land in the area subsequently disappeared as well. This forested area was composed of two curtains of vegetation located on one or both sides of the lagoon with one interruption (Fig. 7). The total loss of forested area is 0.26 km², which is a 100% lost, except for one of the pine-tree. Only 66,000 m² of the land that hosted this forested area hasn't been colonized by sea-water, and 38,000 m² of this land is located at the back of the lagoon in an area that was protected by a stopbank and around the high-school ground.

Fig. 7 Impacts of the tsunami on forested areas in the municipality of Rikuzentakata; (1) and (2) are areas where the trees has been flattened down.

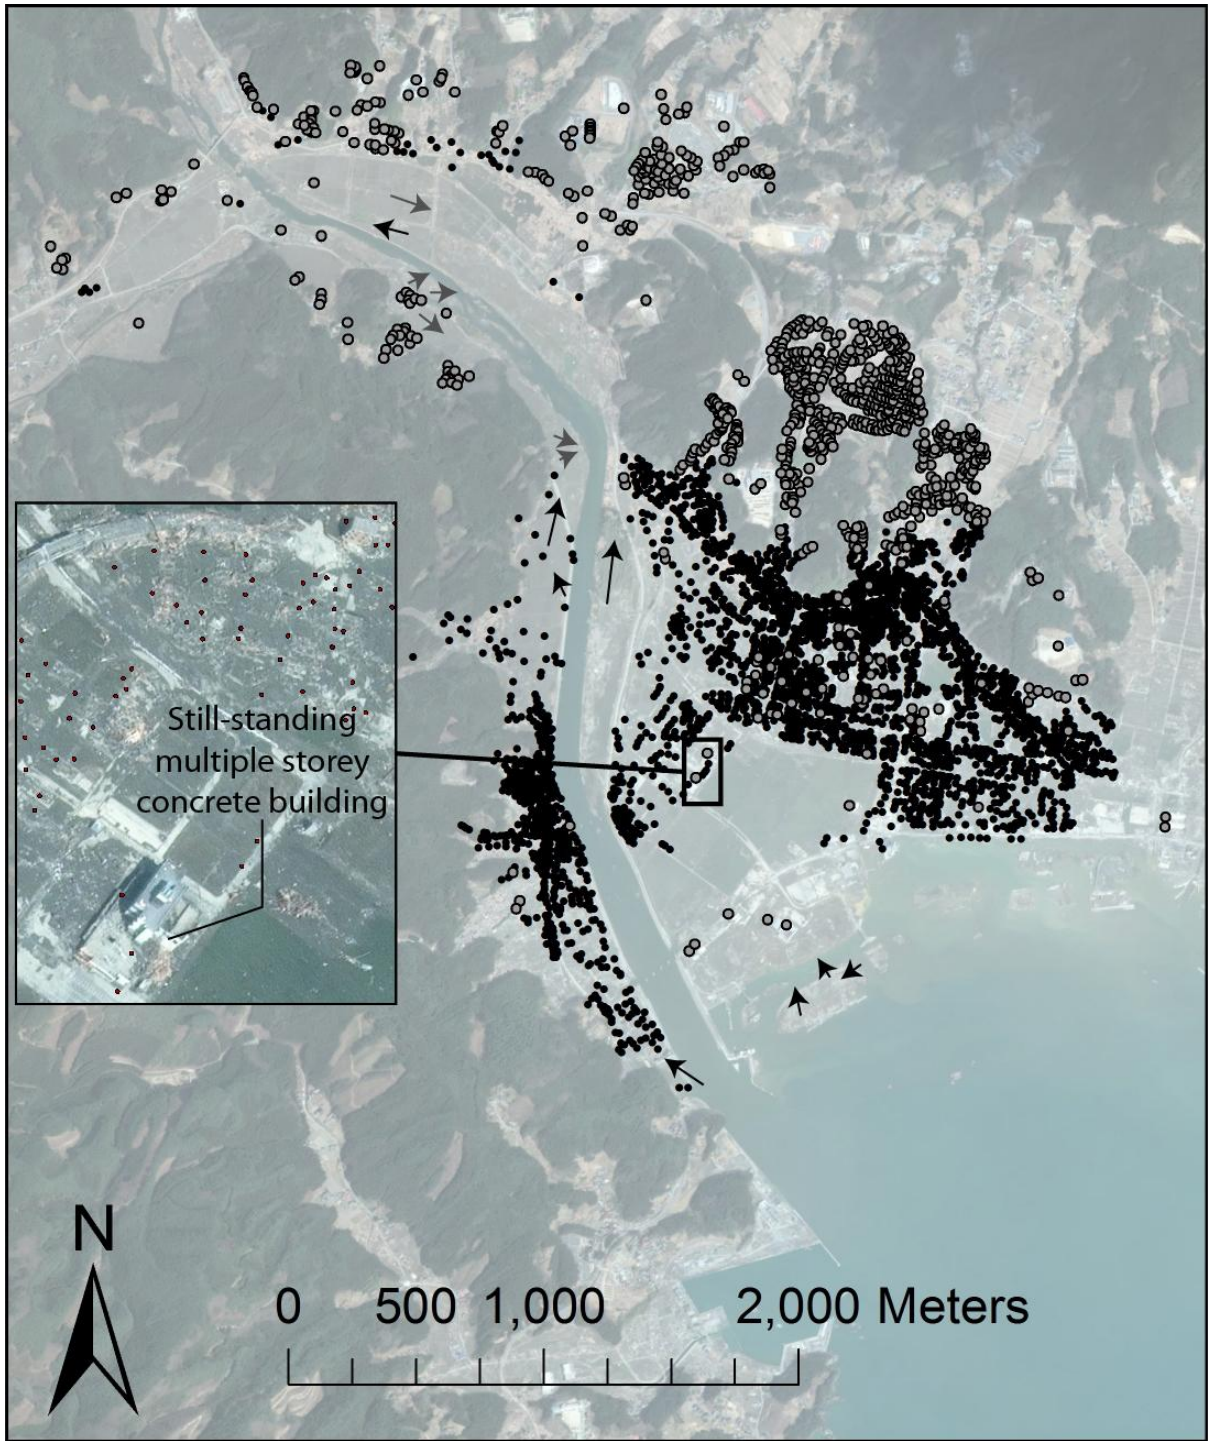
In Rikuzentakata, the ‘light’ constructions have responded poorly to the vertical load and the upward forces produced by the tsunami waves. Based on the image analysis, we have identified different types of destruction: (1) destruction due to sliding over the foundations and/or overturning of the structure, in such a way that we can still observe the concrete slab on the ground; (2) scouring of the surrounding land and of the place where a building was standing. Such destruction has mostly affected timber and steel frame buildings. High-rise buildings (4 storeys and more), with a RC or SRC structure resisted the tsunami (Fig. 10-B)

The area of maximum destruction of buildings is encountered in the lowland plain up to 3 km inland. Buildings have been destroyed (Fig. 10) regardless of the density of the built environment, the orientation of the houses and for most of them their structure (wood or metallic structures). Buildings of the city council, sport-centres and part of school buildings have structurally survived the tsunami. This has moved the barycentre of the Rikuzentakata buildings from 1400 m to 2400 m from the shoreline, modifying the spatial distribution of building density (Fig. 11).

Fig. 10 Location of destroyed buildings (black points) and still standing buildings (grey points); Black arrows are orientation associated with the uprush; Grey arrows are orientations associated with the backwash. The complexity of orientations marker is interesting; however they are very difficult to understand at this stage.

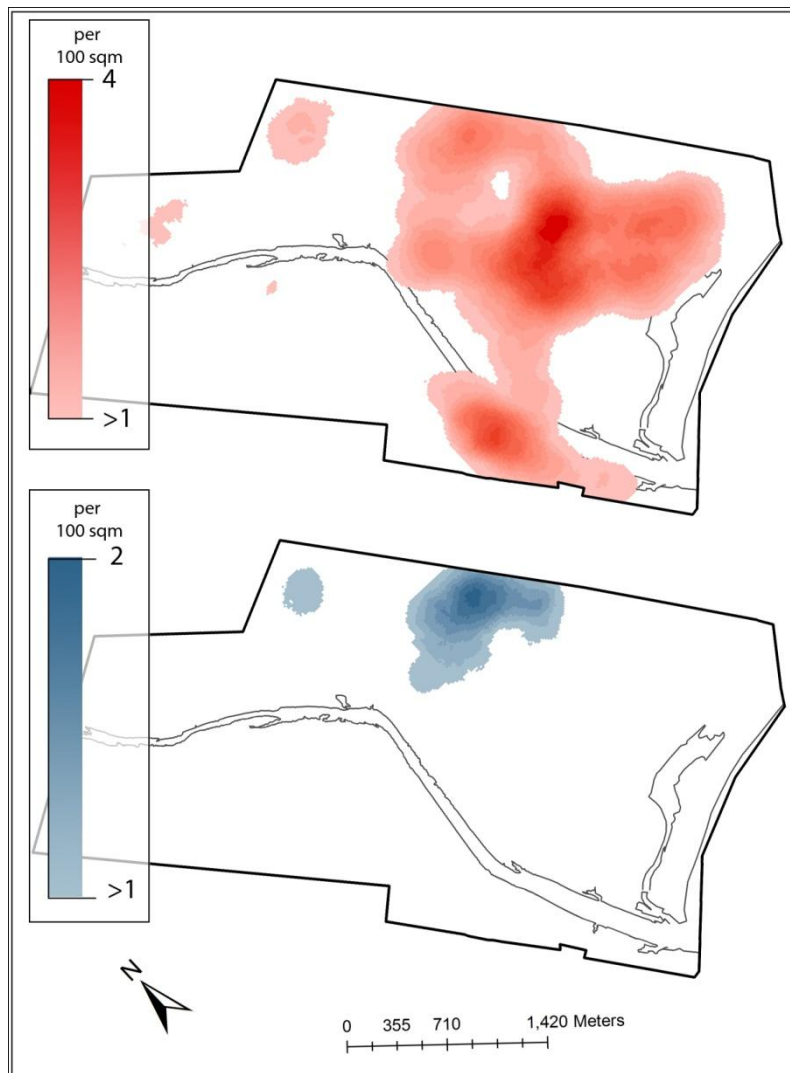
Fig. 11 Change in building density (number of building in a radius of 150 m, data provided in 100 m^2).
